# **Pentium® II Processor Specification Update**

Release Date: February 1999

Order Number: 243337-023

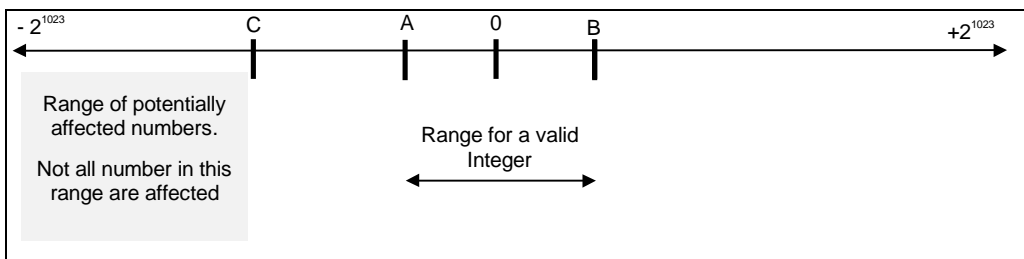
**IMPLICATION:** Erroneous operation results when the operand is so large that it will not fit into the target data size. The operands affected by this erratum are significantly outside (by a factor of 3X) the range that can be, correctly, converted to an integer value. The figure below and corresponding table identifies the normal range of integer numbers (between A and B) and the starting point of the operands affected by this erratum. Discrete failing operands will be present in the range between point C and the maximum negative number that can be represented by the processor ( $-2^{1023}$  in double precision format). Note 2 below gives a qualitative description of the nature of the discrete failing values. Software that does not rely on the Invalid Operation exception flag being set and signaled by either an exception OR by software polling is not impacted by this erratum.

16-bit Operation	A	B	C
	-32,768.0	+32,767.0	< -98304.0
32-bit Operation	A	B	C
	-2,147,483,648.0	+2,147,483,647.0	< -6,442,450,944.0

**WORKAROUND:** Any of two software workarounds will avoid occurrence of this erratum:

1. Range checking performed prior to execution of the FIST[P] instruction will prevent the overflow condition from occurring, and may already be implemented as a coding style.
2. Software can use the presence of MAXNEG in the result integer to indicate that an out of range conversion may have occurred.

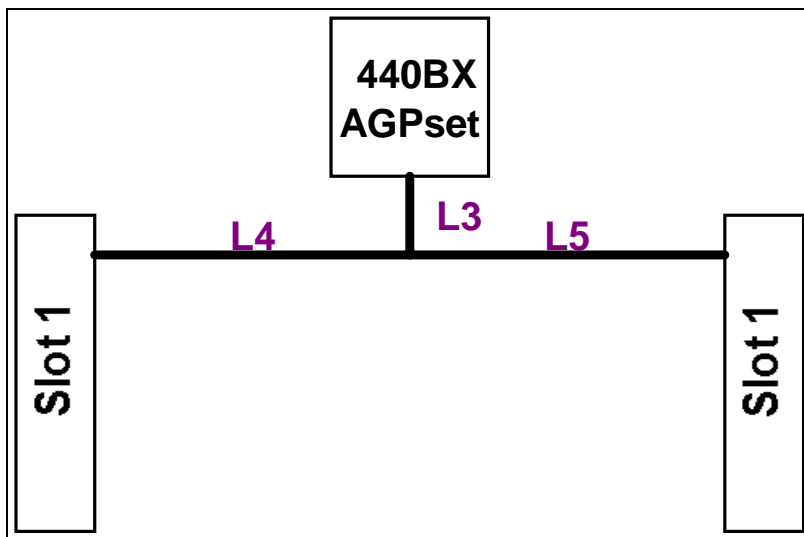
**Figure 2. DP Dual Ended Termination (DET)**

For DP topologies (see Figure 2) installed with a processor and a termination card,  $L4 + L3$  or  $L5 + L3$  must be less than or equal to 4.5". Additionally, for DP platforms with one processor installed, the termination card should be placed in the longer leg.

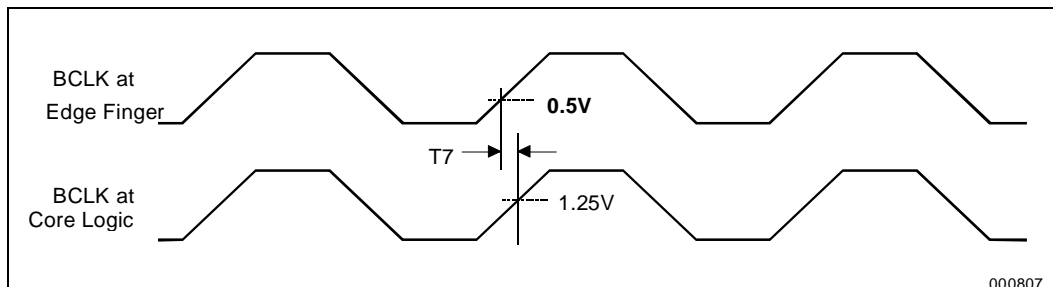
**Figure 6. BCLK to Core Logic Offset**

In Figure 6 of the *Pentium® II Processor at 233 MHz, 266 MHz, 300 MHz, and 333 MHz* datasheet, the following changes should be made:

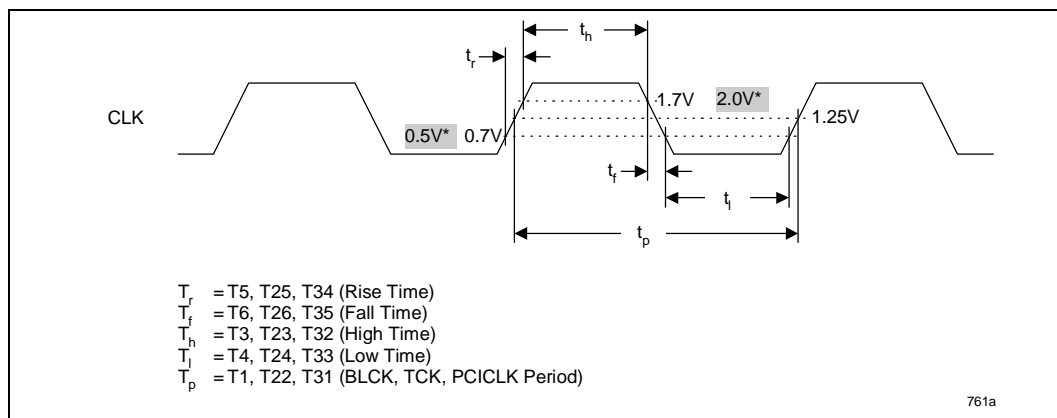
**Figure 7. BCLK\*, PICCLK, and TCK Generic Clock Waveform**

In Figure 7 of the *Pentium® II Processor at 233 MHz, 266 MHz, 300 MHz, and 333 MHz* datasheet, the following changes should be made:
